TECHNICAL INFORMATION SERIES

AUTHOR <i>W. D. Simpson</i> W. D. Simpson		SUBJECT CLASSIFICATION Failure Analysis		NO. 66SD281	
				DATE August 6, 1966	
TITLE FINAL REPORT - FAILURE ANALYSIS AND DESIGN REPORT OF NIMBUS I SOLAR ARRAY DRIVE FAILURE					
ABSTRACT The Nimbus I Weather Satellite failure was investigated by analysis and laboratory tests. The failure was found to be due to deterioration of the grease in the Solar Array Drive motor bearings due to high (>300F) temperature conditions. Corrective design changes lowered temperatures to less than 200F; subsequent laboratory and flight tests have been successful.					
G.E. CLASS II		REPRODUCIBLE COPY FILED AT MSD Documents Library;Valley Forge STC;PO Box 8555; Phila.,Pa. 19101			NO. PAGES 63
GOV. CLASS. Unclassified					
CONCLUSIONS 1. The Nimbus I flight failure was induced by high temperature(greater than 300F) conditions in the Solar Array Drive Motor bearings. The high temperatures caused deterioration of the G300 silicone grease lubricant,increasing motor bearing friction and producing motor stall. 2. The high temperature condition was a design and operating characteristic and was not caused by variabilities or anomalies. 3

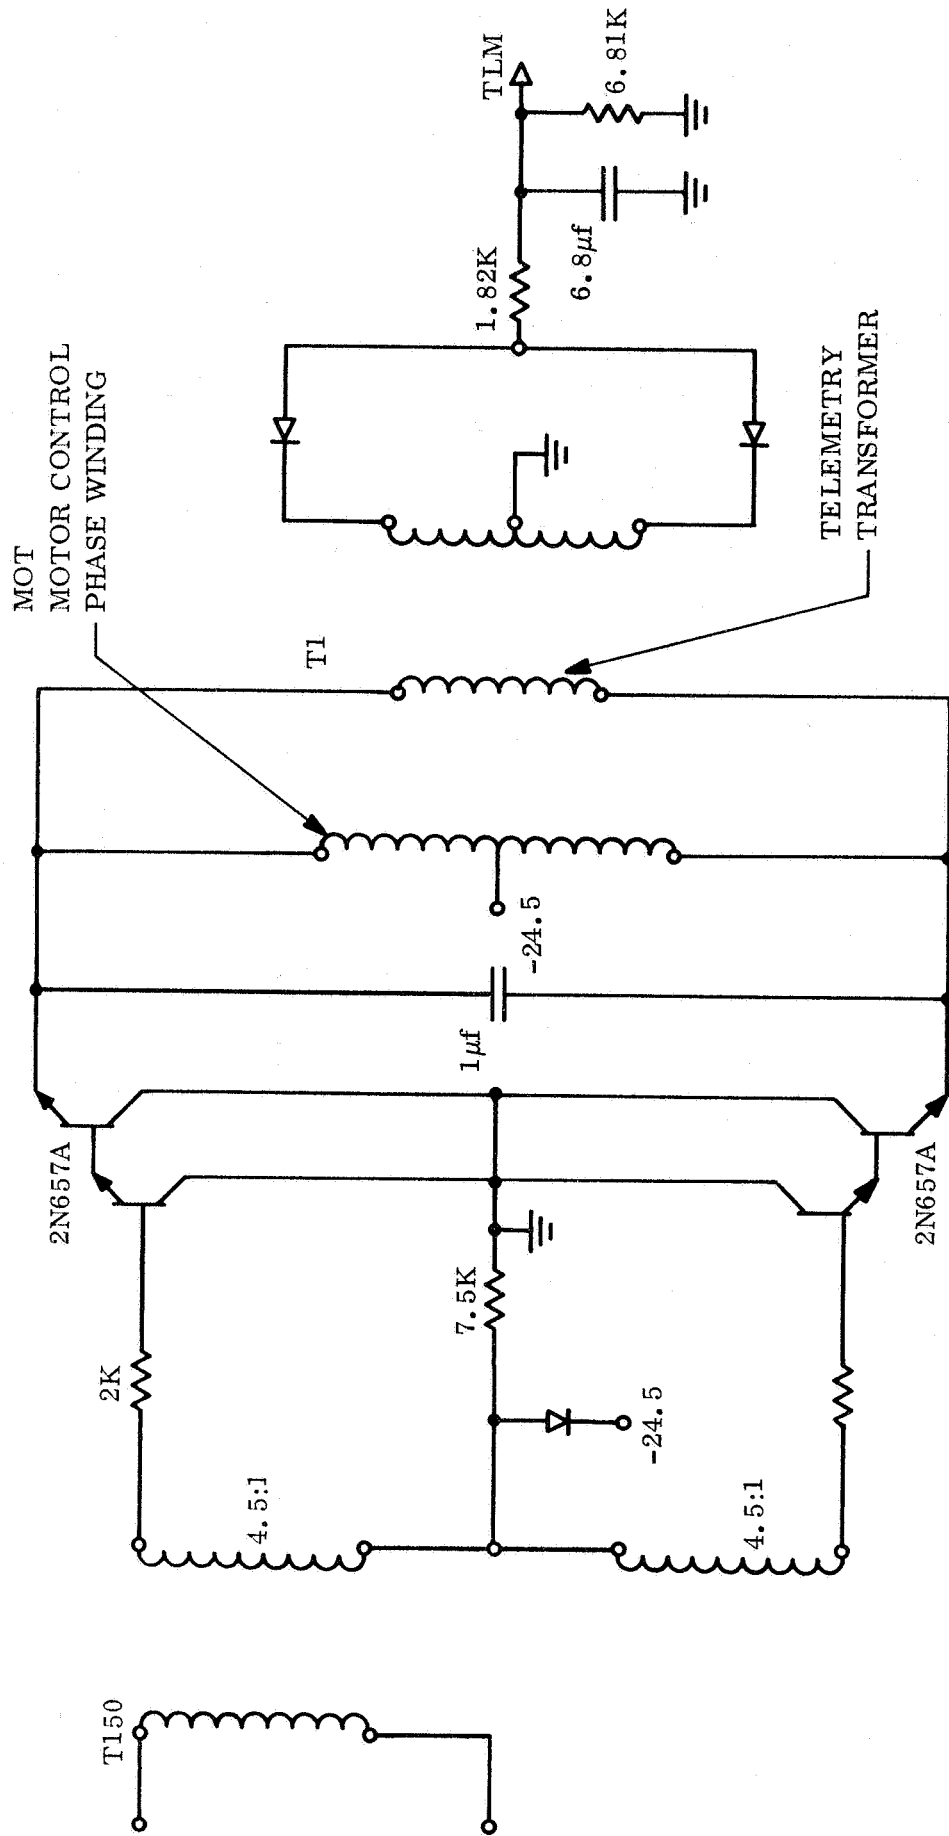
Section 3, Figure 1
Solar Array Drive Amplifier Output Circuitry

The Solar Array Drive amplifier was examined to determine the possible failure modes and the effects on the drive motor and telemetry signals due to each failure. The power stage for the solar array drive amplifier is shown in Figure 1 along with the telemetry circuitry. The possible modes of failure are listed below:

If a short occurred in one of the output transistors, 282 milliamperes DC would flow through one-half of the control winding. The power dissipated in the motor winding would be 6.9 watts. Number 40 wire is used in the motor winding and would be unable to carry 282 ma without failing. Also, as can be seen from Figure 1, a short on either side of the motor winding would cause approximately 24 ma DC to flow through the telemetry transformer. Data presented in Table II shows the effect of DC in the primary of the transformer.

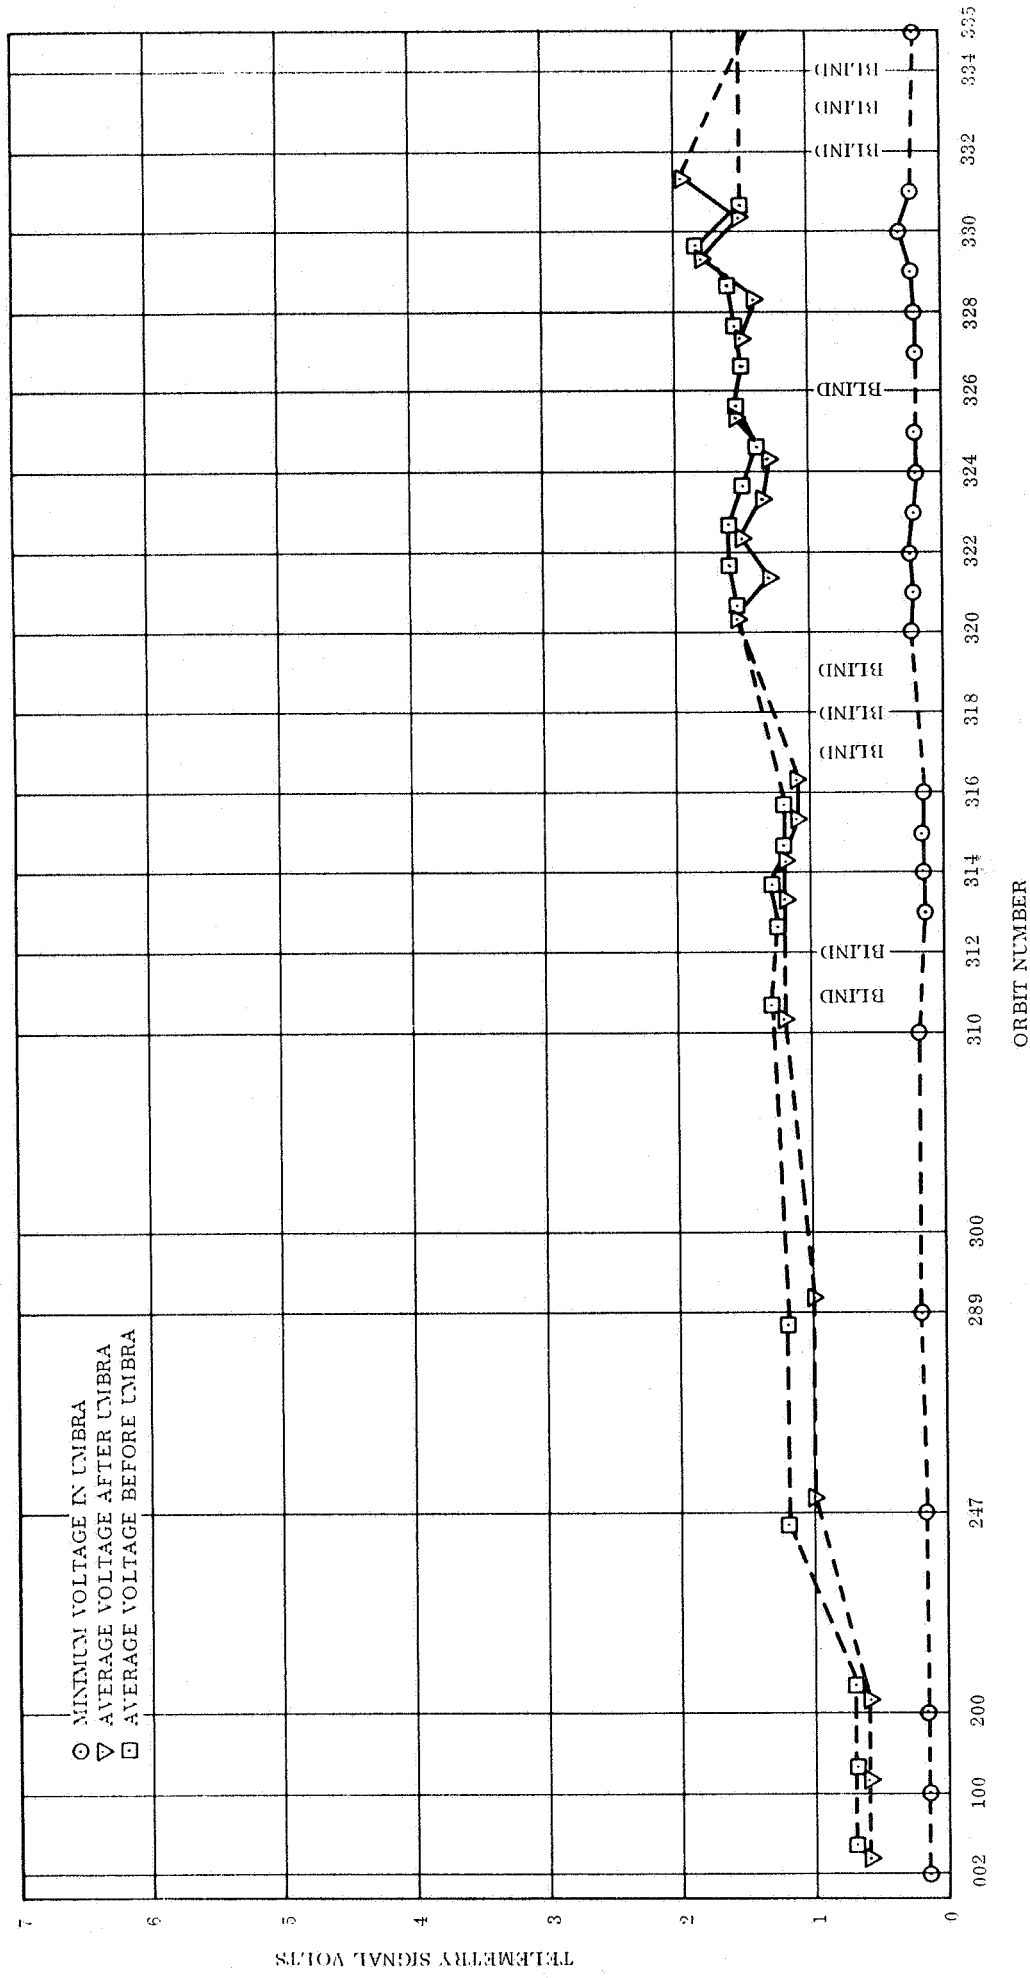
Section 3, Figure 7
Solar Array Drive Voltage History (1)

Figures 7 and 8 show an orbit-by-orbit history of the Solar Array Drive input voltage. Certain trends in input voltage during each orbit are evident. From the first orbits after launch, the tracking voltage required gradually rose from sunrise to sunset, but remained at a low value. After the first two hundred orbits, the average tracking voltage per orbit gradually rose until at a few orbits before the first paddle stoppage, the voltage started to rise at an increasing rate each orbit. The drive moved at less than orbital rate for two orbits (354, 355) and stopped completely for two orbits (356, 357). During the orbits when the array was stopped, a few intervals of motion were noticed during the umbra portions of the orbit in the form of short duration fast movements through arcs of a few degrees.

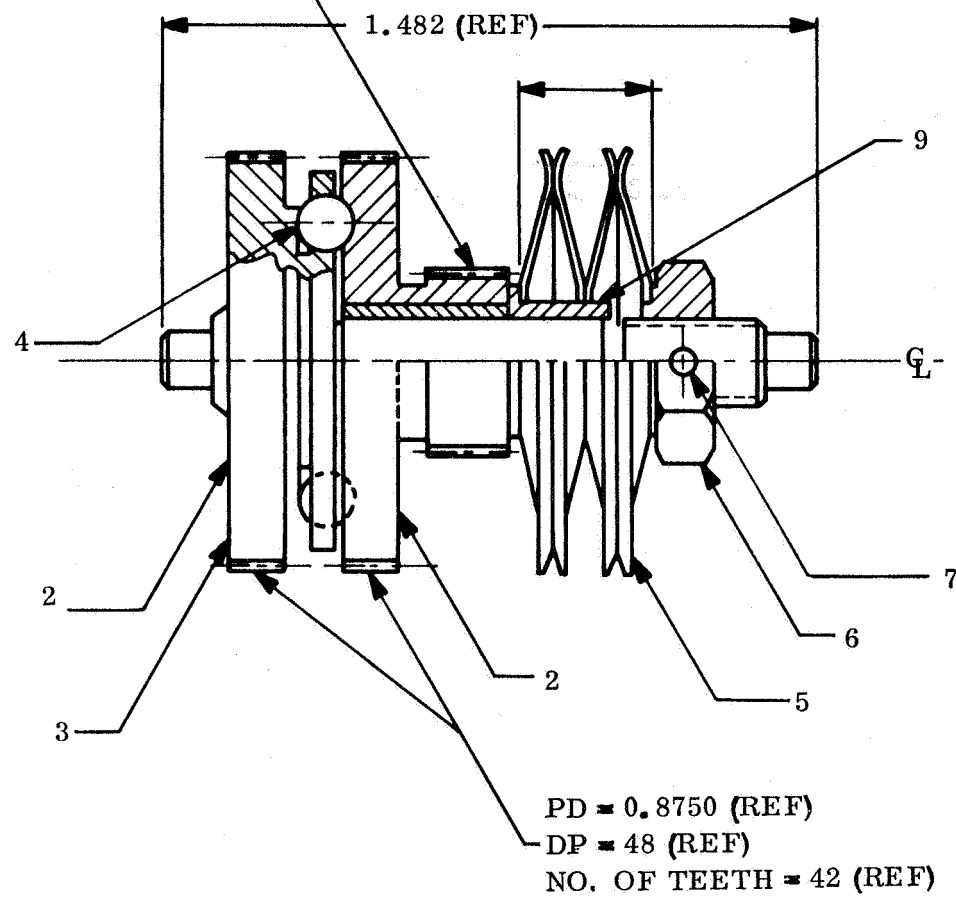
Section 3, Figure 9
Clutch Assembly

The clutch assembly is a ball-detent type device (see Figure 9). The driving member contains a face-plate and a ball cage with eight ball bearings equally spaced circumferentially and bearing axially against the face plate. The driven member contains a face plate with eight conical pockets corresponding to the location of the eight balls in the driving member and is loaded against the driving member by four Belleville washers. Normally, the balls are retained in the conical pockets of the driven member and the driver and driven members rotate together without slippage. Under high torque conditions (corresponding to approximately 350 in-oz at the output shaft) the balls are forced out of the ball pockets and a detenting action occurs.

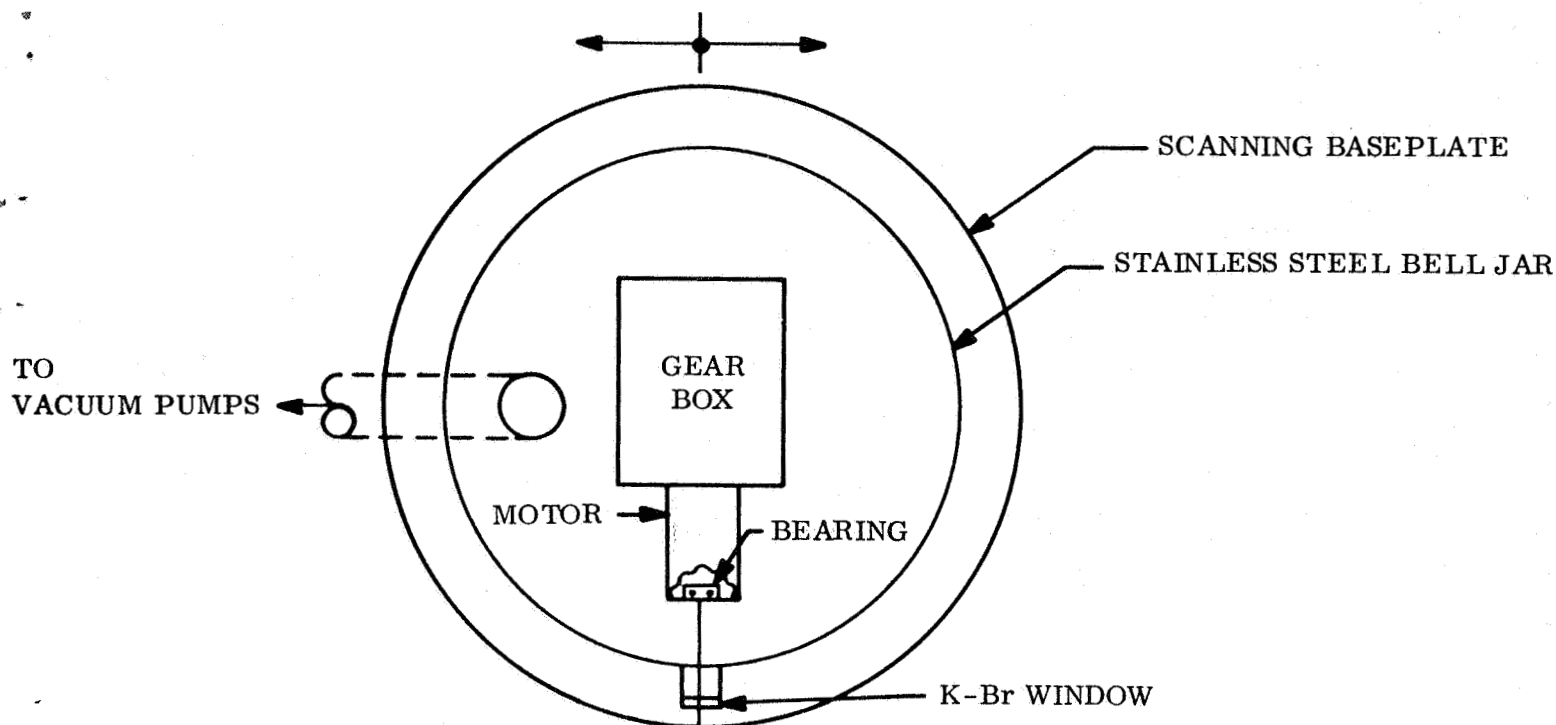
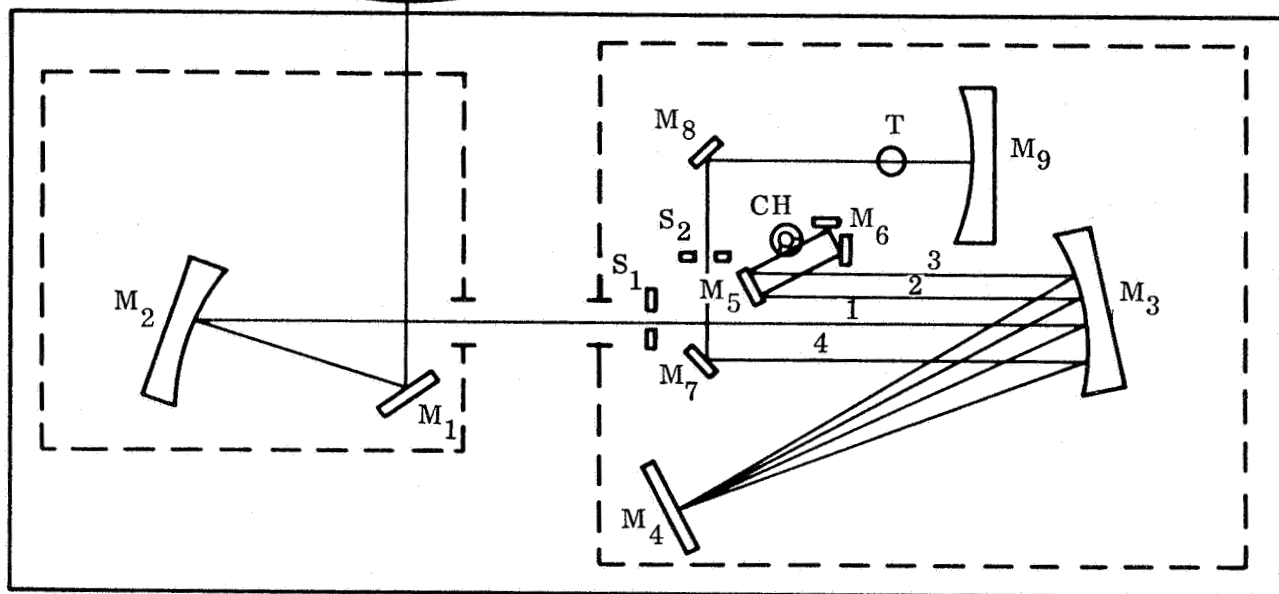
Section 4, Figure 2
 Sketch of Test Setup for IR-Scanning of a
 Rotating Motor Bearing

Measurement of actual motor bearing temperatures was performed by a novel technique developed for this investigation. The motor was run in a vacuum chamber with its rear bearing exposed and scanned externally through a KBR window by an infrared sensing radiometer (see Figure 2 and Figure 3). The method by which the temperatures were obtained was rather complex because of the difficulty of obtaining a true temperature calibration. It was necessary to set up a dummy bearing having a known, fixed temperature over the entire surface of the bearing and with similar IR radiation characteristics such as the same configuration, materials, and surface treatment. The radiometer was made to scan across this bearing and a recording of radiometer output versus scan position made. This procedure was repeated at various temperature levels to produce a set of calibrating curves. The radiometer then was made to scan the motor bearing while the motor was operating at stabilized conditions and a recording of the radiometer output was made. As an additional calibration check, a thermocouple was attached to the outer race of the bearing and read simultaneously when the radiometer scanned this area. A typical recording of the radiometer scan is shown in Figure 3. The recorded outputs during the dummy bearing and motor bearing scans were then compared and the true motor bearing temperatures determined by interpolation of the data. By this means the actual rotor shaft, ball bearing inner race, ball retainer, and outer race temperatures were measured while the rotating parts were operating normally. These measurements indicated temperatures in excess of 300°F at

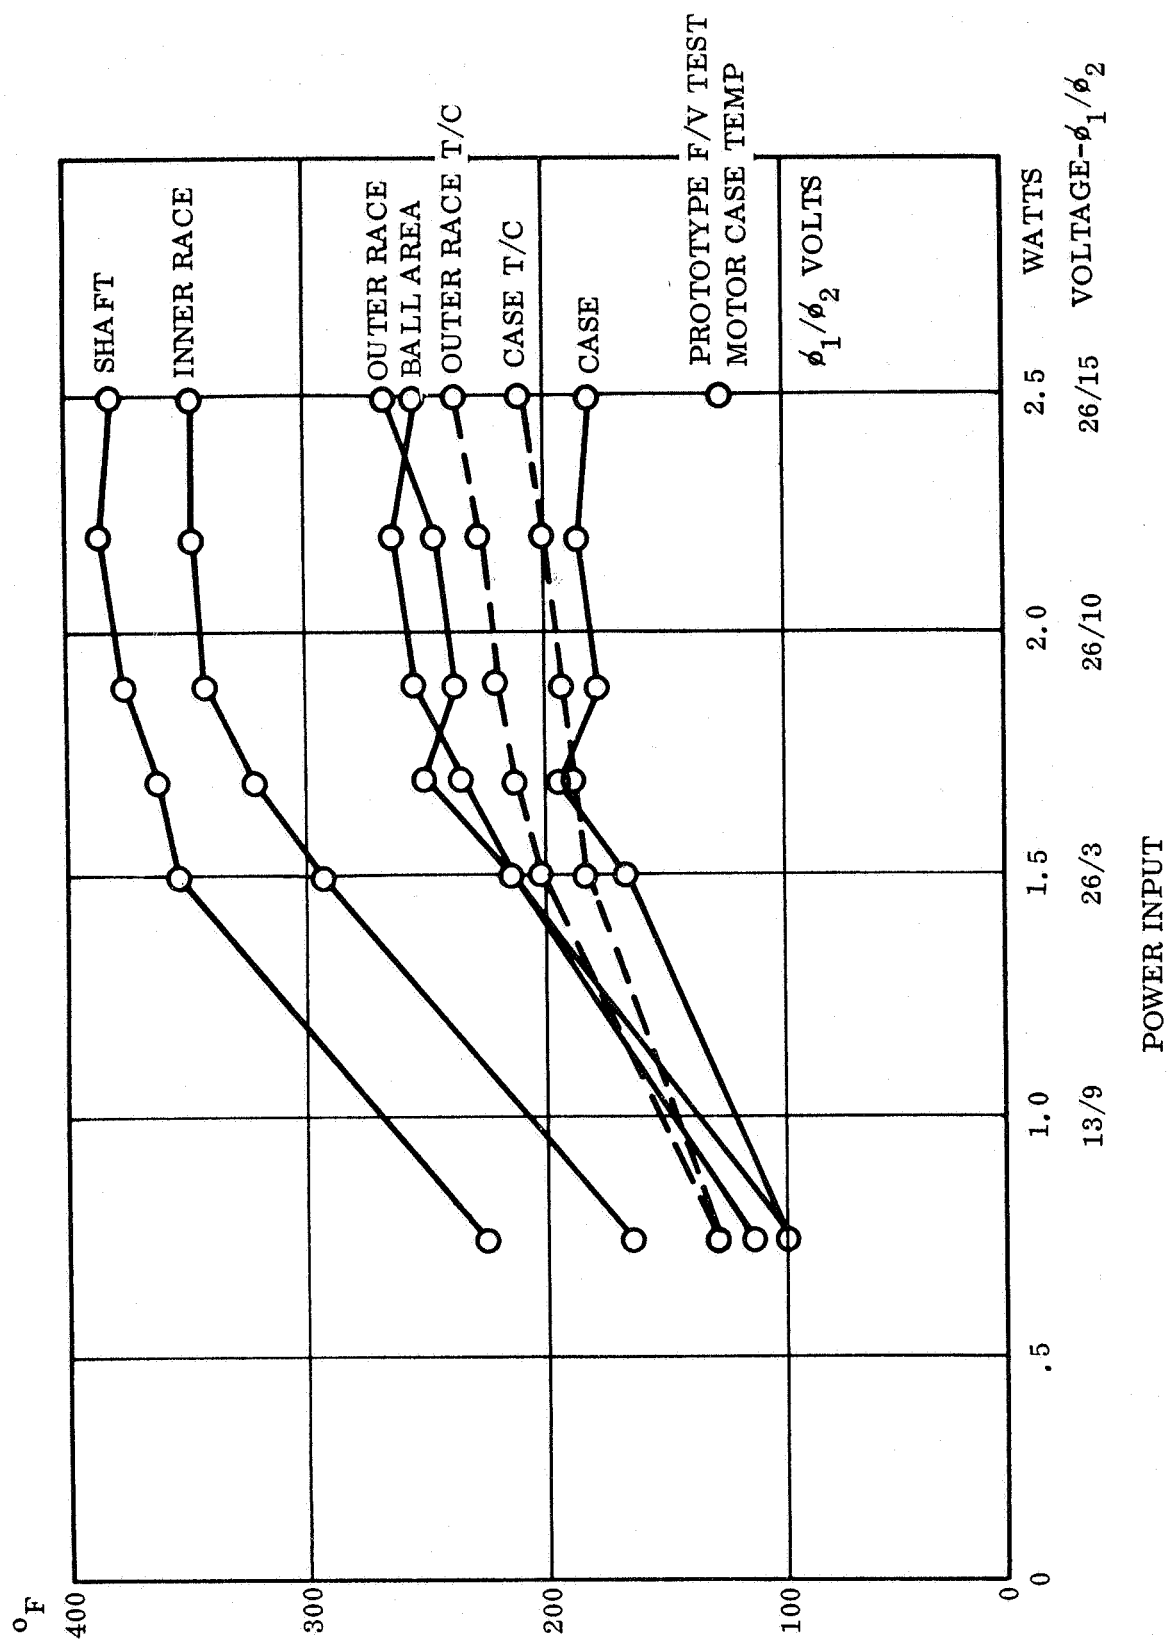
Section 4, Figure 4
 Temperature Profile Test Size 8 MGH - Vacuum

the bearing inner race and ball retainer at the same time that the outer race and motor bearing were running much cooler at less than 200°F, which was the maximum temperature measured previously by conventional thermocouple techniques (see Figure 4).
